Four Leaf Home Inspections

Property Inspection Report

Client(s): **Mr. & Mrs. Home Buyer**
Property address: **11 Stillwell Street**
Anywhere, USA 00010
Inspection date: **Wednesday, June 1, 2022**

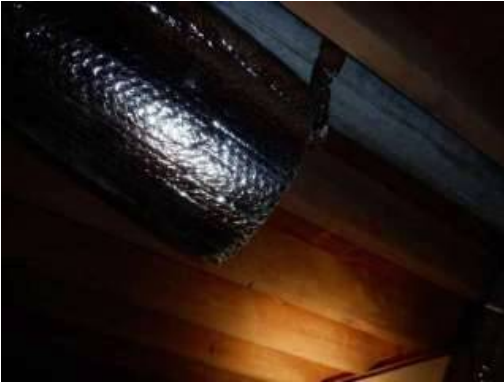
Photo 3-1

- 3) 🛠️ secure falling vent insulation

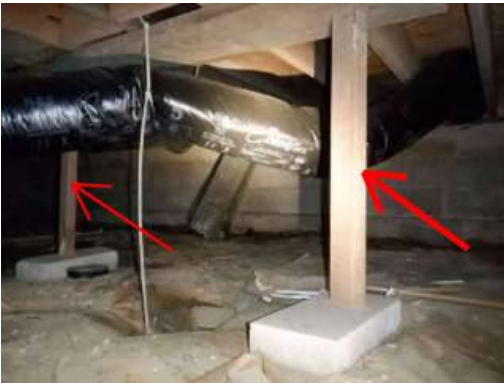
Photo 4-1

- 4) 🔍 Support of flooring with 2x4 sitting on concrete block in two areas in crawl space. These areas look to be under converted garage living space. Recommend further evaluation by a qualified professional.

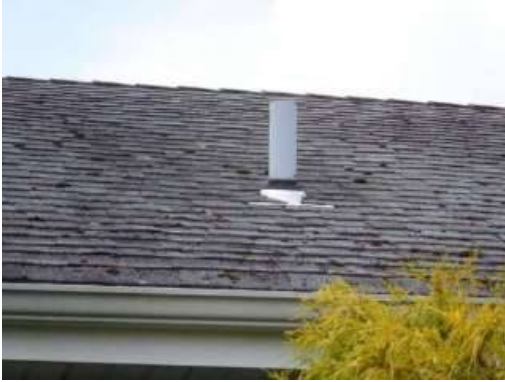
Photo 6-1

Moss Growth on North side of roof. A thick growth of moss works like a sponge, keeping the roofing damp for long periods, and it can lift edges of shingles, making them vulnerable to blowing off in a windstorm.

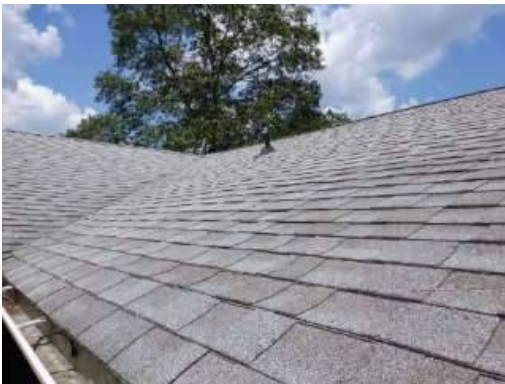
Photo 7-1

Single layer Asphalt Shingle Roofing appears to be brittle and worn and losing granular protection and is accumulating in roof gutters. Recommend evaluation by a qualified professional.

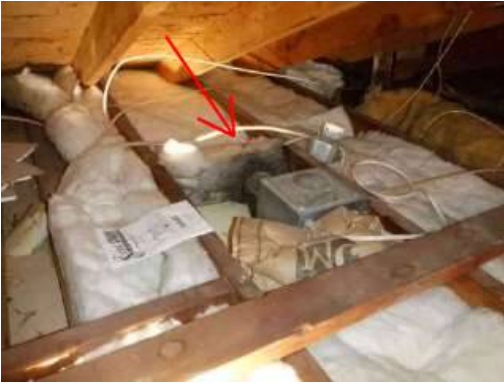
Photo 8-1

Master bath ventilation fan improperly venting into attic space. Excess moisture in attic space can cause mold growth. Recommend proper venting to outside by qualified professional.

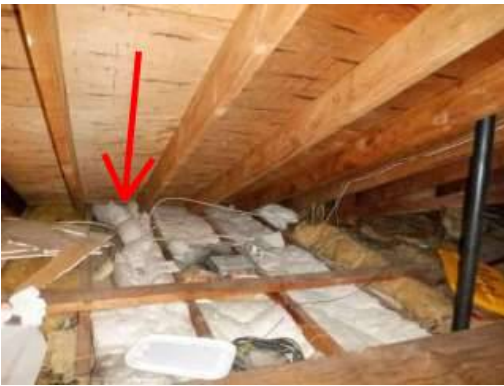
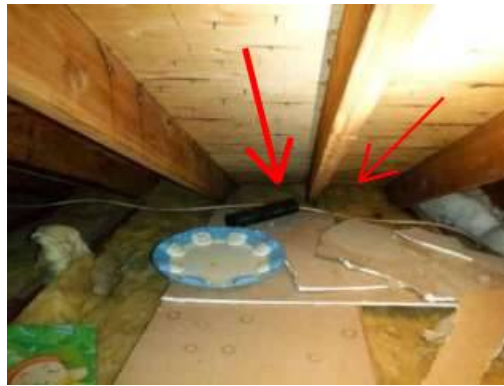
9) Exterior soffit vents are obstructed by insulation, increasing the risk of mold, mildew, and rot damage. Venting with cross ventilation is recommended. Further evaluation by a qualified professional is recommended.

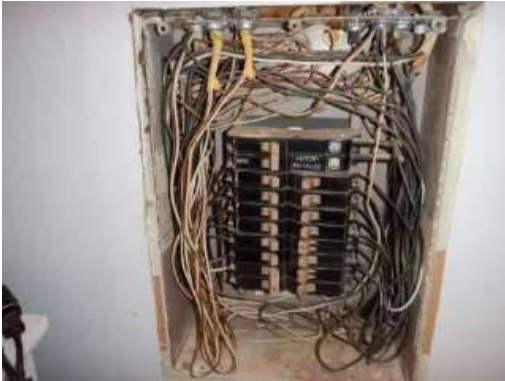
11) ✓ 100 Amp service

Photo 11-1 Cutler & Hammer Brand Panel
100 Amp Service

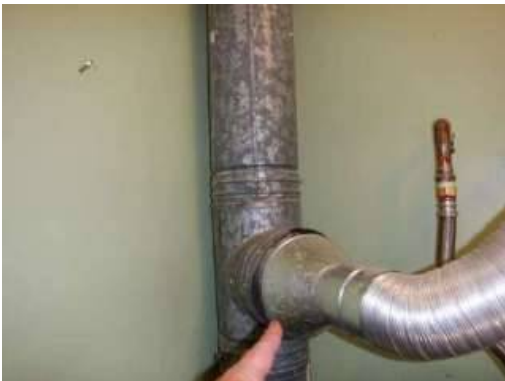
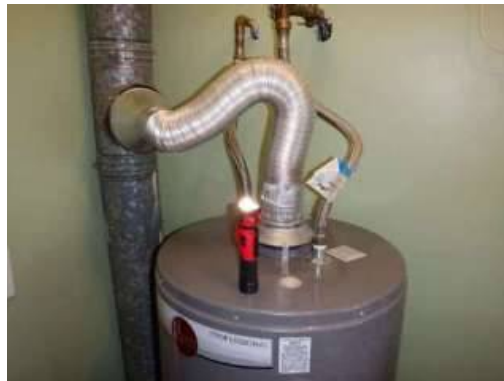
12) ✘ Inadequate slope of exhaust gases. Slope is critical to the exhaust of products of combustion. Exhaust must be able to move to the chimney by convection. A poor slope can result in backdrafting of combustion gases or inadequate venting of combustion gases. These are life safety issues. Also, connection to main flue does not appear sealed around connection.

Recommend further evaluation by a qualified professional.

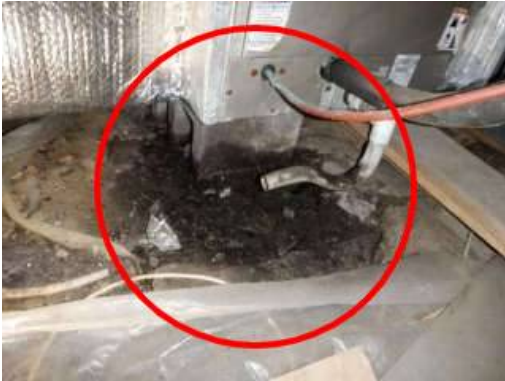
Photo 13-1

Air conditioning unit in crawl space is draining condensation directly into crawl space. Air conditioner units during peak usage can generate 5-20 gallons a day. Excess moisture in a crawl space can promote mold. Recommend repair/evaluation by a qualified professional.

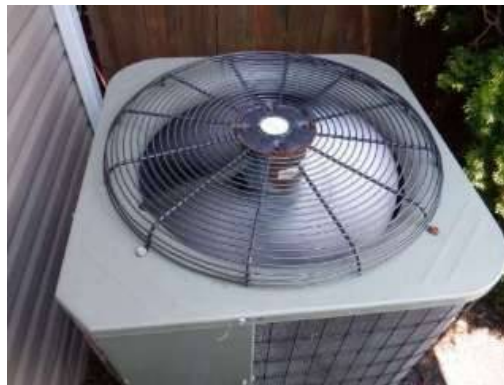
Payne Outside Condenser unit is approx 16 years old.

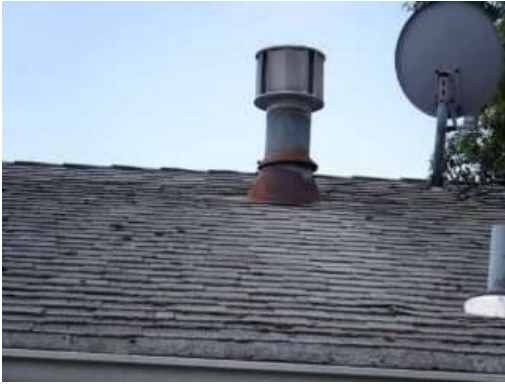
Photo 15-1

B-Vents should be at least 2 ft. above the roof line as an implication for a poor draft .

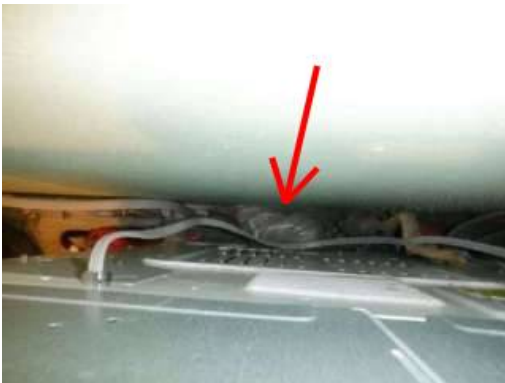
Photo 16-1

16) 🛠️ Dryer vent in need of cleaning/repair. Ignoring regular cleaning can lead to fire. Recommend service by a qualified professional.

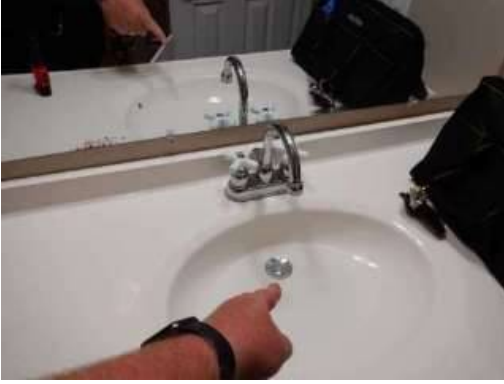
Photo 17-1

17) 🛠️ Main Bathroom sink dose not drain due to malfunctioning drain mechanism.

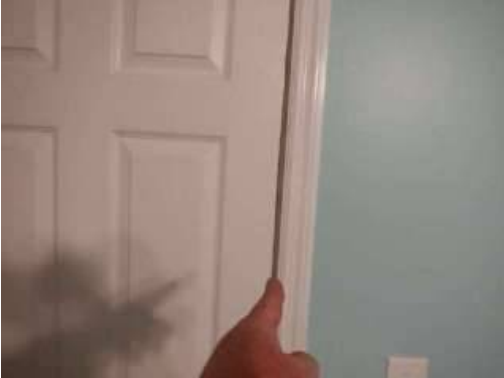
Photo 18-1

18) 🚪🔍 Bedroom door not aligned leaving gap when closed.
