Four Leaf Home Inspections

Property Inspection Report

Client(s): **Mr. & Mrs. Home Buyer**
Property address: **11 Stillwell Street**
Anywhere, USA 00010
Inspection date: **Wednesday, June 1, 2022**

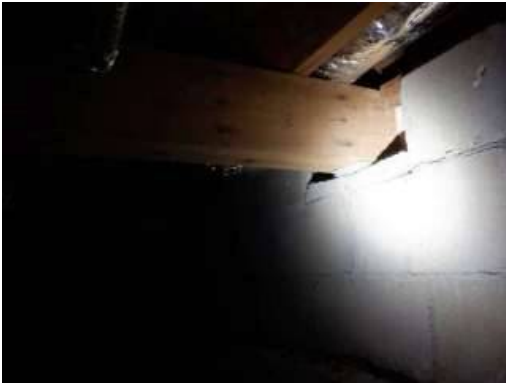
19) No sign of Wood destroying insect found at time of inspection in crawl space.

Photo 19-3 Main Beam in Crawl Space.

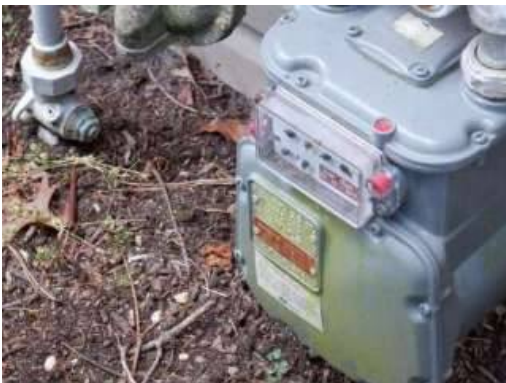
Photo X-11 Gas Meter outside
