Four Leaf Home Inspections

Property Inspection Report

Client(s): **Mr. & Mrs. Home Buyer**
Property address: **11 Stillwell Street**
Anywhere, USA 00010
Inspection date: **Wednesday, June 1, 2022**

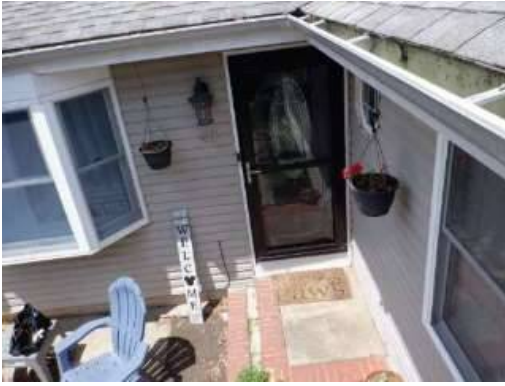
Photo 1-1

Time started: 1:00 pm
Present during inspection: Client, Realtor
Weather conditions during inspection: Dry (no rain), Sunny
Temperature during inspection: Warm
Type of building: Single family
Buildings inspected: One house
Age of main building: 51
Source for main building age: Realtor

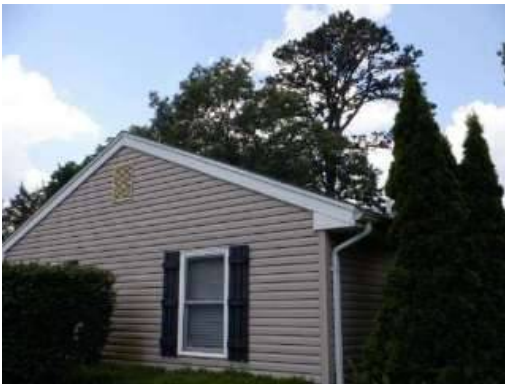
Photo 2-1

Vinyl siding on entire exterior of home in good repair:

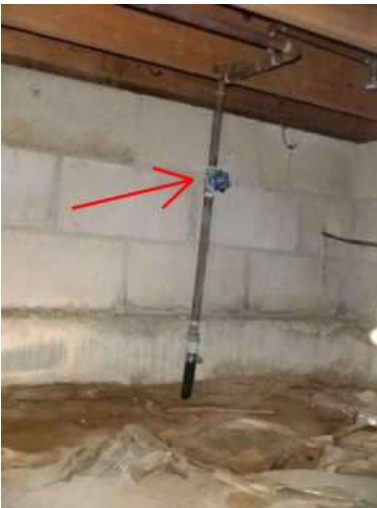
Photo 5-1

- 5) Water shut off in South west corner of crawl space.

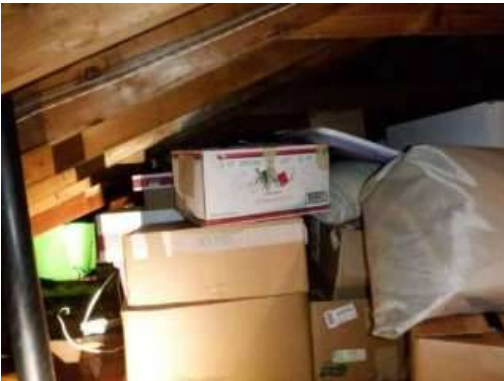
Photo 10-1

10) The presence of attic storage from current owner prevented a complete evaluation of entire attic space.

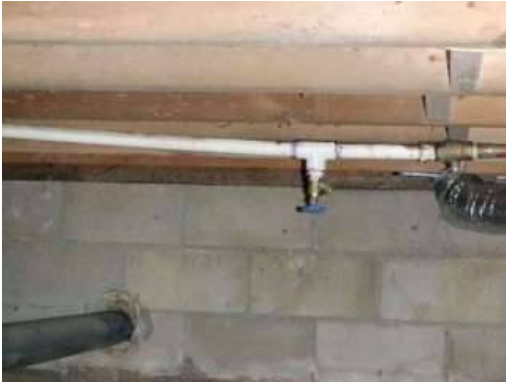
Photo 19-1

19) No sign of Wood destroying insect found at time of inspection in crawl space.

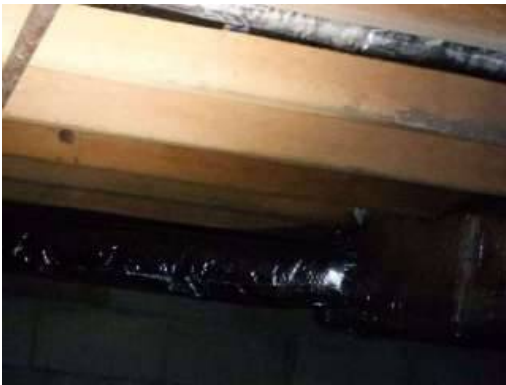
Photo X-52 Main Beam Support
